RESIDENTIAL INSPECTION REPORT

1247 Maple Ridge Lane, Springfield, IL

May 13, 2026

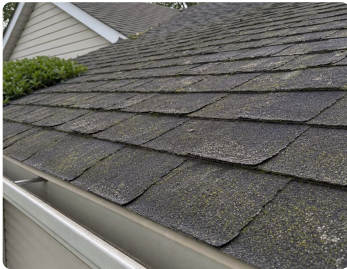
1.01 Roof Coverings

Asphalt shingle roof is near the end of its useful service life. Significant granular loss visible on multiple slopes. Several shingles exhibit curling and lifting at edges. Algae staining present throughout. Recommend full roof replacement by a licensed roofing contractor within 1-2 years or sooner if leaks develop.

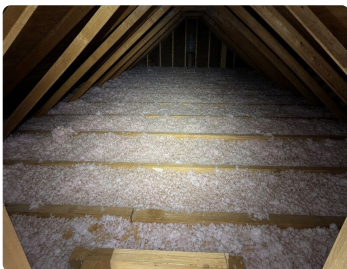
1.03 Insulation

Blown-in fiberglass insulation present but depth is insufficient, averaging approximately 4 inches in most areas. Current minimum recommendation is R-38 (approximately 12 inches of blown fiberglass). Recommend adding insulation to achieve current energy code minimums, which will improve heating and cooling efficiency.

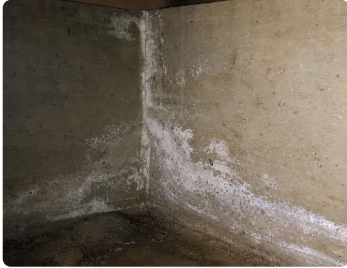
2.03 Moisture and Water Intrusion

Minor efflorescence (white mineral deposits) visible on the foundation wall in the northeast corner of the crawlspace, indicating historic water seepage. Area was dry at time of inspection. Monitor during rain events; apply waterproof sealant to affected area as a preventive measure.

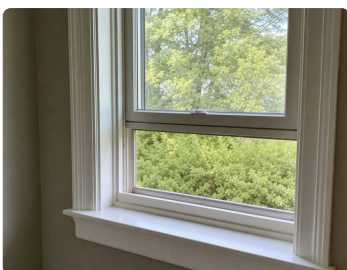
2.06 Bedroom #3

Third bedroom functional. Window sash operational but the rough opening width measures approximately 18 inches, which falls below the 20-inch minimum egress width required by current residential codes for sleeping rooms. Recommend evaluation by a licensed contractor to determine if window replacement or enlargement is warranted for life-safety compliance.

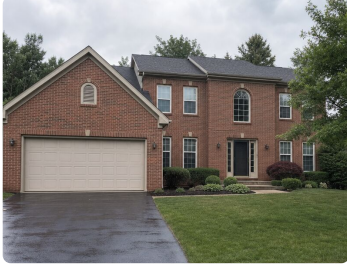
2.1 Wall Cladding and Trim

Brick veneer in good condition overall. Mortar joints intact with no significant spalling or cracking. Weep holes present and clear at base course. Exterior paint on trim in good condition.

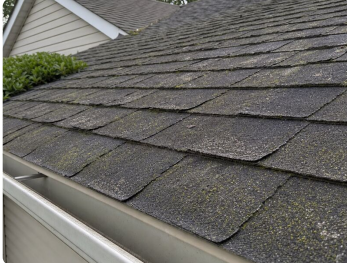
3.1 Roof Coverings

Repair or Replace

Asphalt shingle roof is near the end of its useful service life. Significant granular loss visible on multiple slopes. Several shingles exhibit curling and lifting at edges. Algae staining present throughout. Recommend full roof replacement by a licensed roofing contractor within 1-2 years or sooner if leaks develop.

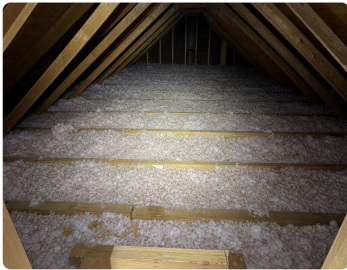
4.2 Insulation

Repair or Replace

Blown-in fiberglass insulation present but depth is insufficient, averaging approximately 4 inches in most areas. Current minimum recommendation is R-38 (approximately 12 inches of blown fiberglass). Recommend adding insulation to achieve current energy code minimums, which will improve heating and cooling efficiency.

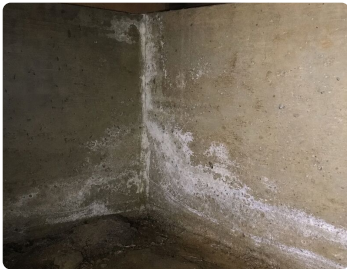
6.3 Moisture and Water Intrusion

Monitor

Minor efflorescence (white mineral deposits) visible on the foundation wall in the northeast corner of the crawlspace, indicating historic water seepage. Area was dry at time of inspection. Monitor during rain events; apply waterproof sealant to affected area as a preventive measure.

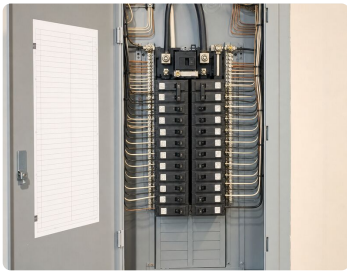
7.2 Main Panel and Sub Panels

200-amp Square D load center. Panel is properly secured and labeled. No double-tapped breakers observed. Wiring neatly organized. All breaker spaces filled or blanked. Adequate working clearance maintained in front of panel.

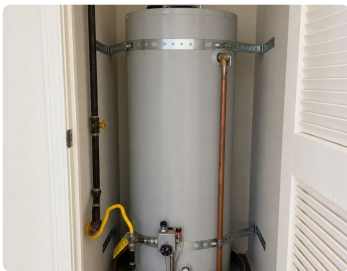
8.3 Water Heater

50-gallon natural gas water heater, manufactured 2018 (approximately 8 years old). Unit is in good working condition. Temperature/pressure relief valve present with drain line properly terminated. Combustion air supply adequate. Seismic strapping installed.

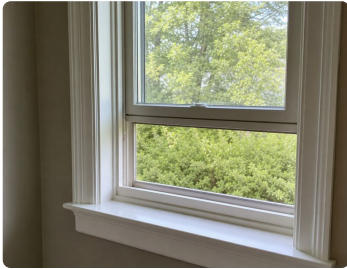
12.11 Bedroom #3

Monitor

Third bedroom functional. Window sash operational but the rough opening width measures approximately 18 inches, which falls below the 20-inch minimum egress width required by current residential codes for sleeping rooms. Recommend evaluation by a licensed contractor to determine if window replacement or enlargement is warranted for life-safety compliance.

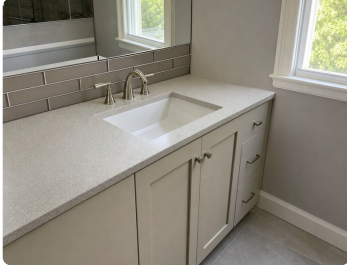
13.1 Bathroom #1

Master bathroom in good condition. Shower enclosure with tile surround, grout intact with no cracking or missing sections. Exhaust fan present and operational. GFCI-protected outlets. No evidence of moisture or water damage at walls or floor.

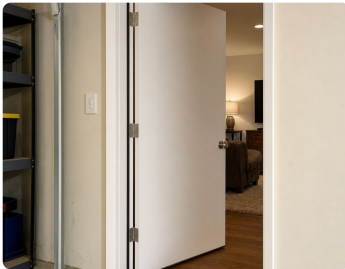
16.3 Fire Separation

Garage-to-living-space door is solid-core with self-closing hinges. Door seals properly. No penetrations observed in common wall between garage and living space.
